Navajo Abandoned Uranium Mine

Site Screen Report

Melvin Benally No. 1 AUM Site

Navajo AUM Northern Region

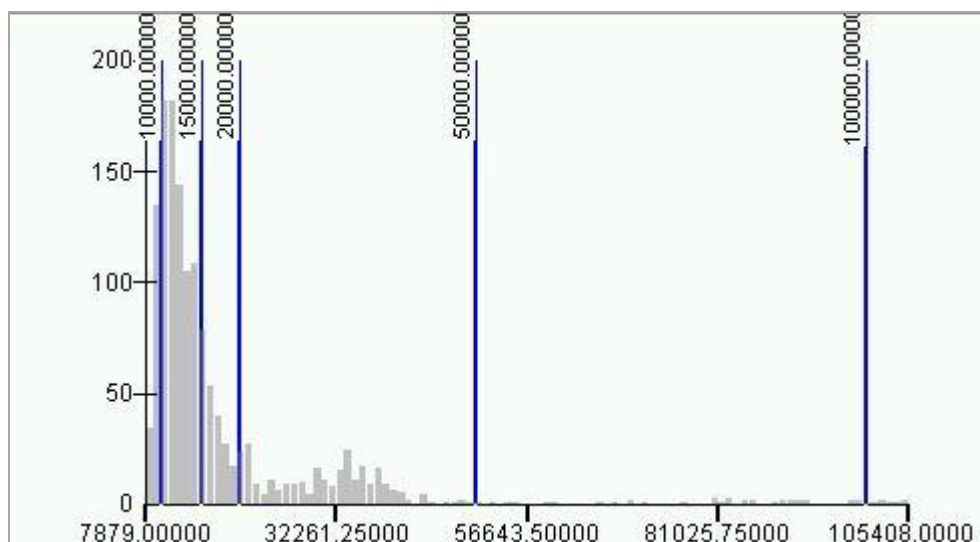
The following chart and statistics were generated by ESRI ArcGIS 9.3.1, and show the general distribution of the site gamma radiation measurements. The horizontal X axis represents the gamma radiation reading levels in cpm (lowest levels to the left). The vertical Y axis represents the frequency of each gamma radiation level.

Count:	1421
Minimum:	7879.00000
Maximum:	105408.00000
Sum:	25561415.00000
Mean:	17988.32864
Median:	13002.00000
Standard Deviation:	14321.31390

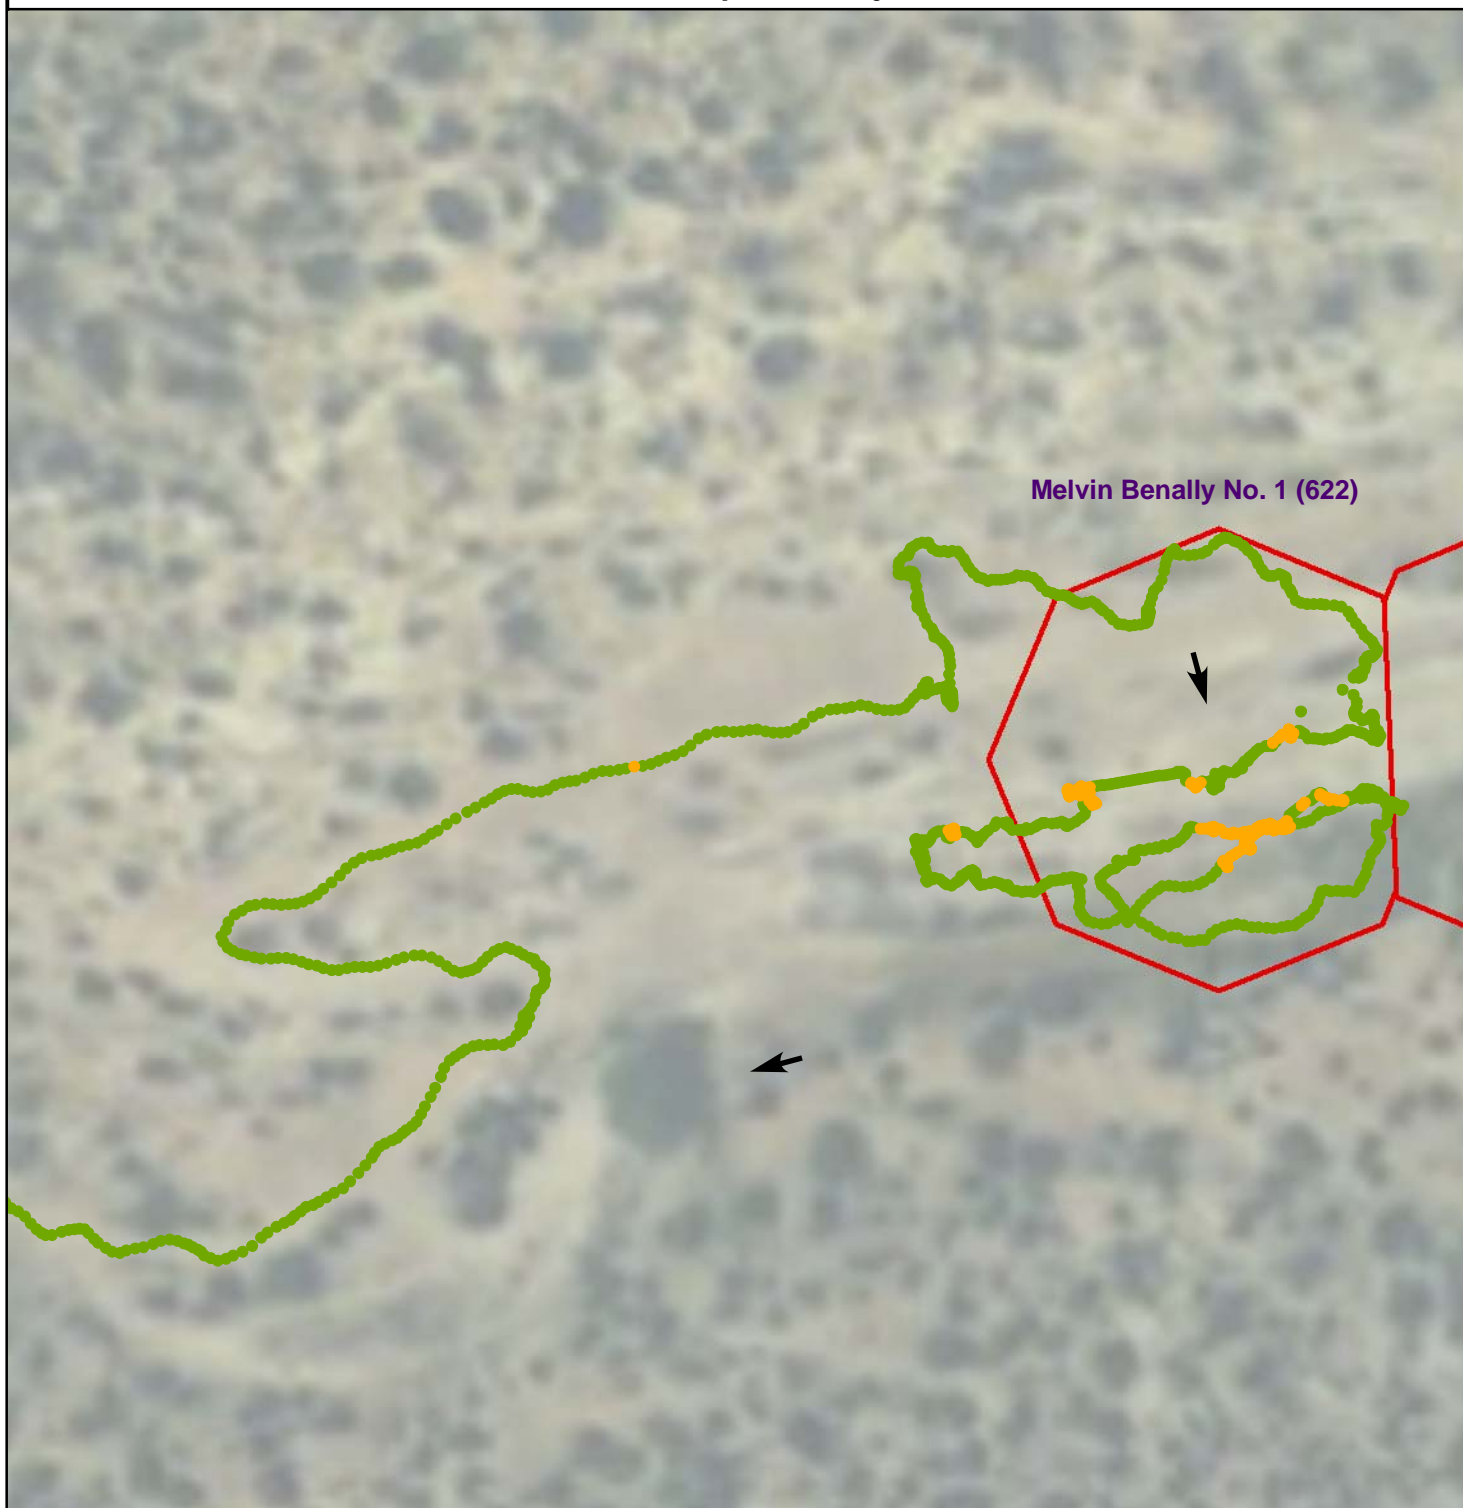
**Figure 1 - Gamma Radiation Measurements, Above Two Times Background
Melvin Benally No. 1 (622)
Sweetwater Chapter, Navajo Nation**

A total of 1421 gamma radiation measurements were collected from the mine site, ranging from 7879 cpm to 105408 cpm. Measurements collected in the vicinity of the workings were found at levels up to approximately 105,000 cpm. The measurements are represented in Figures 1 and 2.

Gamma survey conducted 06/2010
Measured as counts per minute (cpm)

Average background = 11,275 cpm

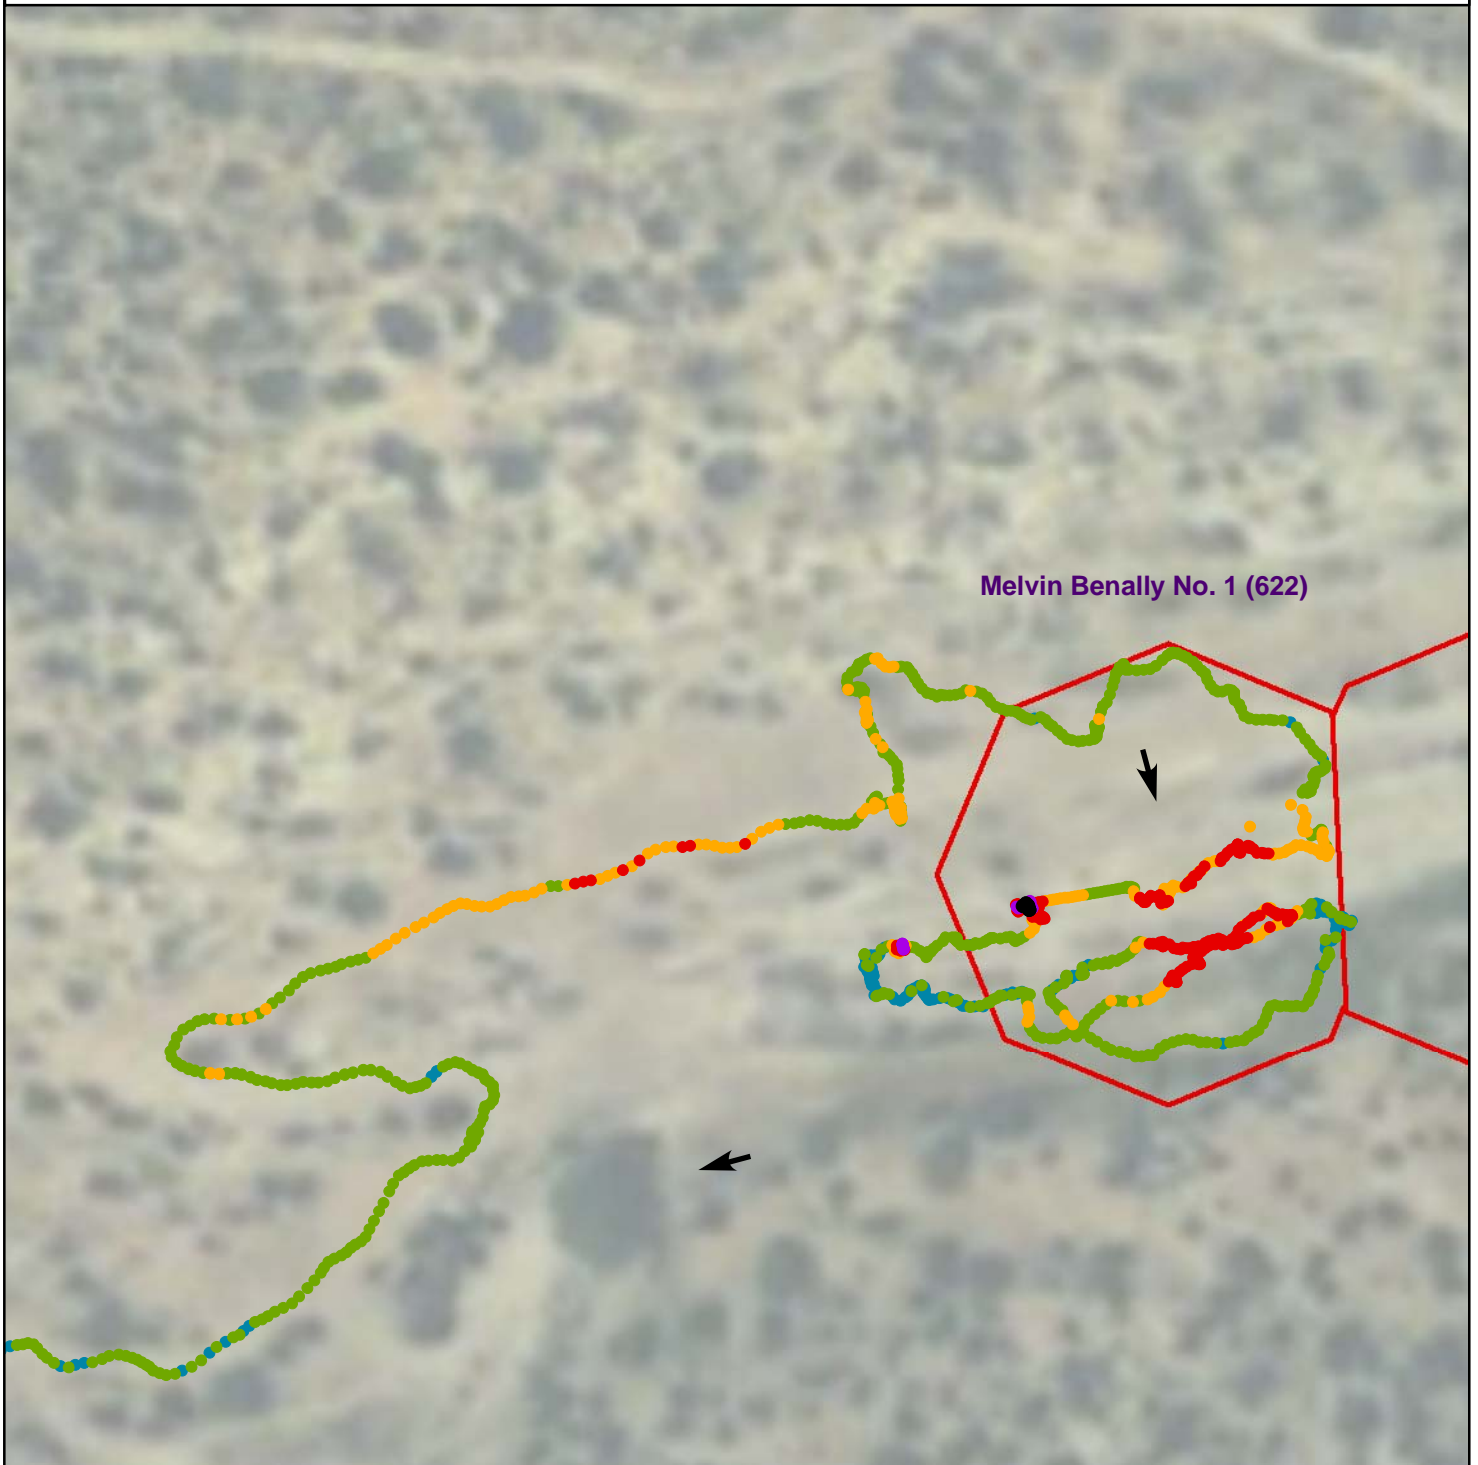
Figure 2 - Gamma Radiation Measurements
Melvin Benally No. 1 (622)
Sweetwater Chapter, Navajo Nation

Gamma survey conducted 06/2010
 Measured as counts per minute (cpm)

Average background 11,275 cpm
